A WEST WING UPDATE

Ben Abernathy, Chair of the Building Committee

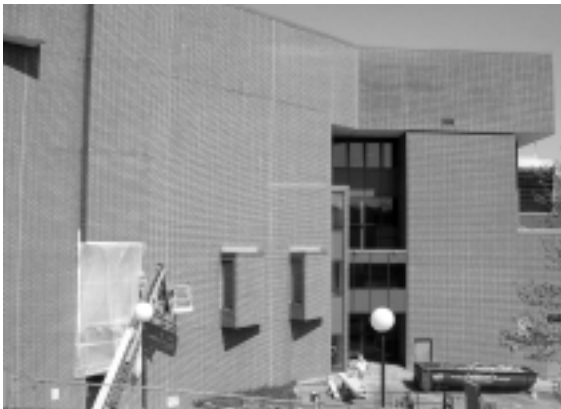
Fig. 1. Late summer: first floor window wings were removed from the south side of Weeks I.

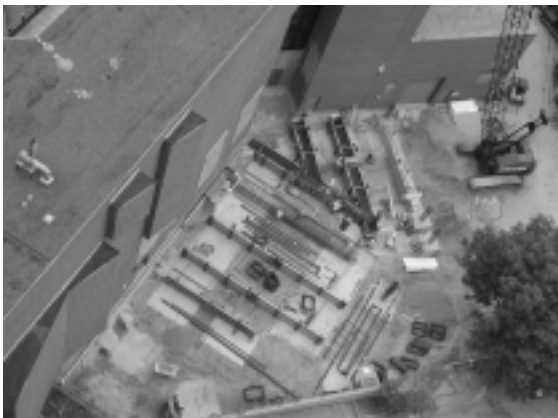
Fig. 2. The loading dock was removed and foundations poured.

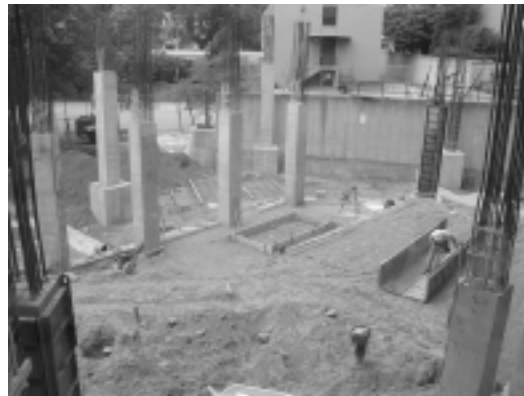
Fig. 3. Concrete and rebar support beams were constructed in stages.

It was interesting to watch the various tradesmen bring their own specialty to the job. Starting at the end of June they poured rebar-reinforced concrete columns that would be the permanent support for the floors: Steel for each reinforced support column was assembled by hand (cut and welded) and hoisted into position. Then forms were assembled around the rebar, and finally filled with concrete. This job took approximately four different specialists, each supervising a stage of the process.

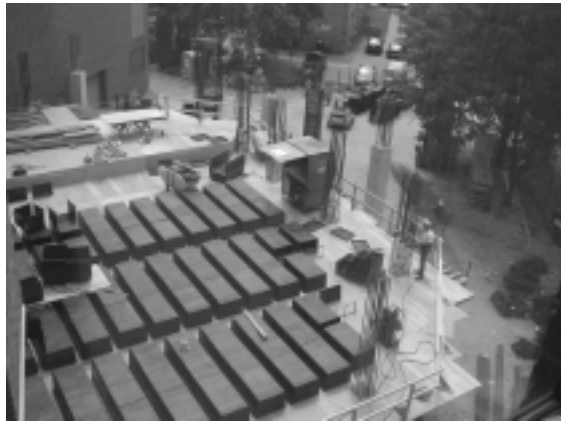
Fig. 4. The "bathtubs," forms for the underside of the floors.

To prepare for pouring the floors they laid out plywood decking over temporary supports. The floor itself would be concrete, but to create cavities within it, to lighten the weight of the floor, they laid out a honeycomb of upside-down black steel pans, which resembled bathtubs. In between these upside-down “bathtubs,” they created a webbing of steel rebar for further reinforcement. When all that was done, they would pour the concrete, let it set and cure for a few days, and then and knock out the original plywood decking. The progress of each floor was actually quite rapid, despite the fact that they could not start the next floor until the strength of the existing one had been verified by independent tests.

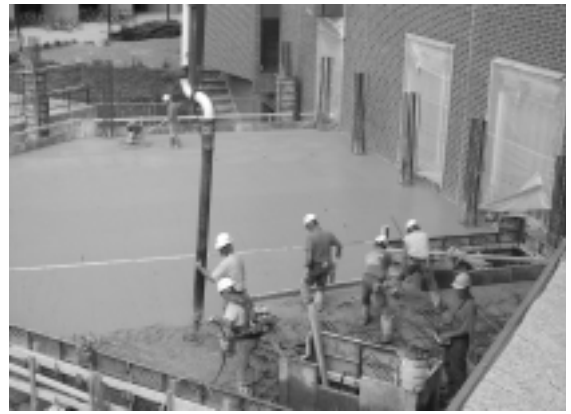
Fig. 5. Concrete mixed at ground-level was delivered overhead via lengthy piping. Pouring the floors was a real team effort.

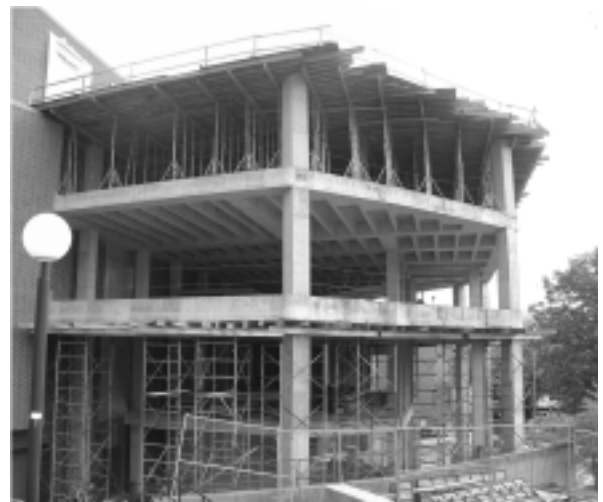
Fig. 6. Early fall. Temporary plywood decking for the fourth floor is in place and the decking between the second and third floors has been removed.

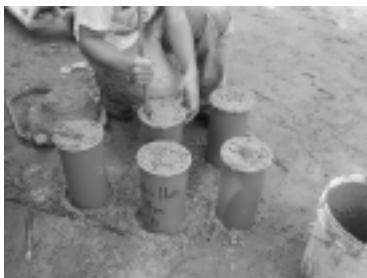
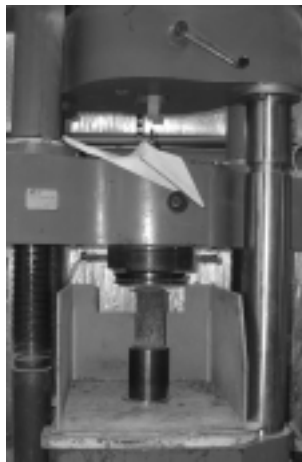
Figs. 7a, 7b. As floors were poured concrete samples were tested in an independent lab.

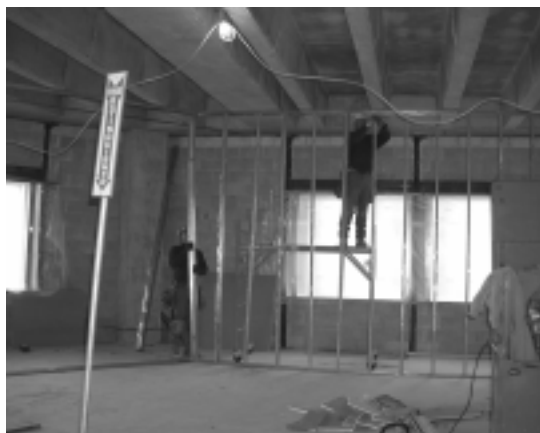
Fig. 9. With winter here, window openings are covered by plastic and workers frame in corridor walls.

After the floors were poured, the roof, cinder block exterior walls, and window frames were installed. By late December any points open to the outdoors were sealed up with plastic sheeting, so that the heat could be turned on. This was not as simple as flipping a switch—pipe fitters, electricians, and duct workers had been working for months installing the necessary connections. But the cold didn’t stop work from being done on the exterior. In a heated, adjustable scaffolding, bricklayers worked up and down the building laying the exterior finishing bricks. Meanwhile, in the heated indoors, workers were installing metal framing to define rooms and hallways.

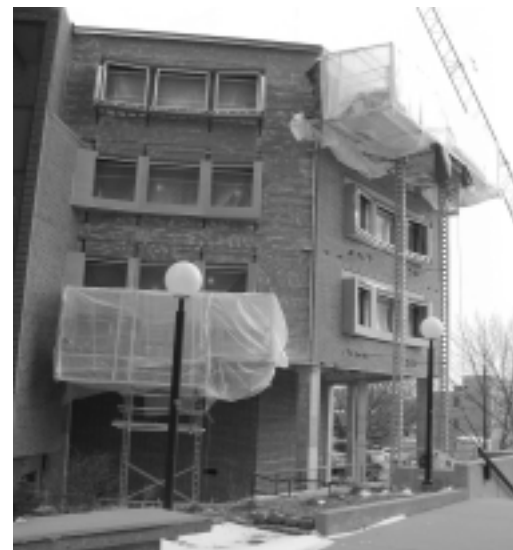
Fig. 8. December, the west face. Bricklayers are working in heated scaffolding. The new brick matches that on Weeks I and II.
